**Archaeological
Building Survey:**

Worsley New Hall
Cold War Bunker,
Worsley. Final
Version.

Client: Peel
Investments (North)
Ltd.

Report No: 02/2012

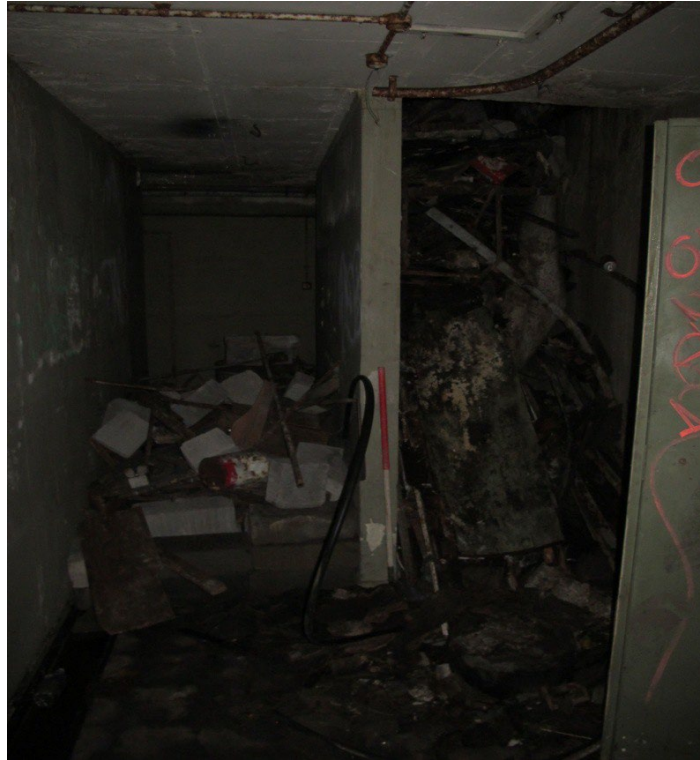
Figure 9: General shot of corridor G1 with blocked staircase S2 to the right. Looking north.

This room ran throughout the ground floor of the building providing access into all rooms on this level. G1 measured 1.20m wide and approximately 2.50m in height. The floor, walls and ceiling were constructed from reinforced concrete slabs. Iron piping and ventilation trunking ran round the top of the walls throughout the corridor.

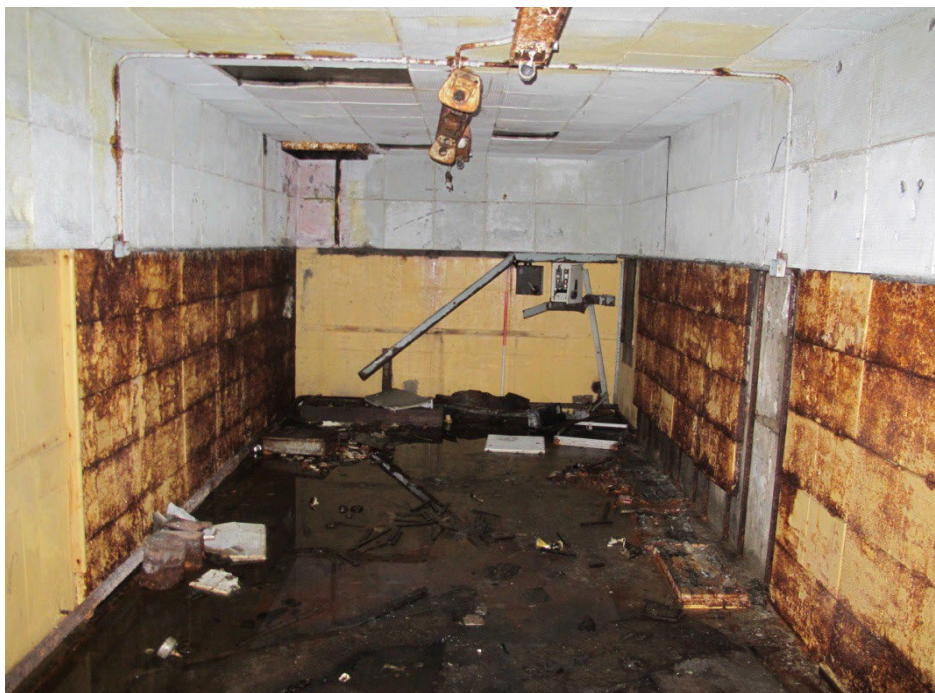
Figure 10: General shot of southwest radio control room G2 with sound proofing tiles covering the walls and ceiling. Looking west.

This room lay in the south-western corner of the building. The ceilings and walls were entirely covered in square asbestos tiles, which probably acted as a sound-proofing system. The floor was constructed from concrete. At the western end of the room were two wall-mounted boxes containing possible fuse boxes. These boxes were linked to an aluminium bar also mounted on the western wall. Two ceiling lights and associated switches were located in the central portion of the room. A possible iron air vent built into the ceiling was identified in the south-western corner of the room. The sound proofing tiling indicated that this was a radio/communications room.

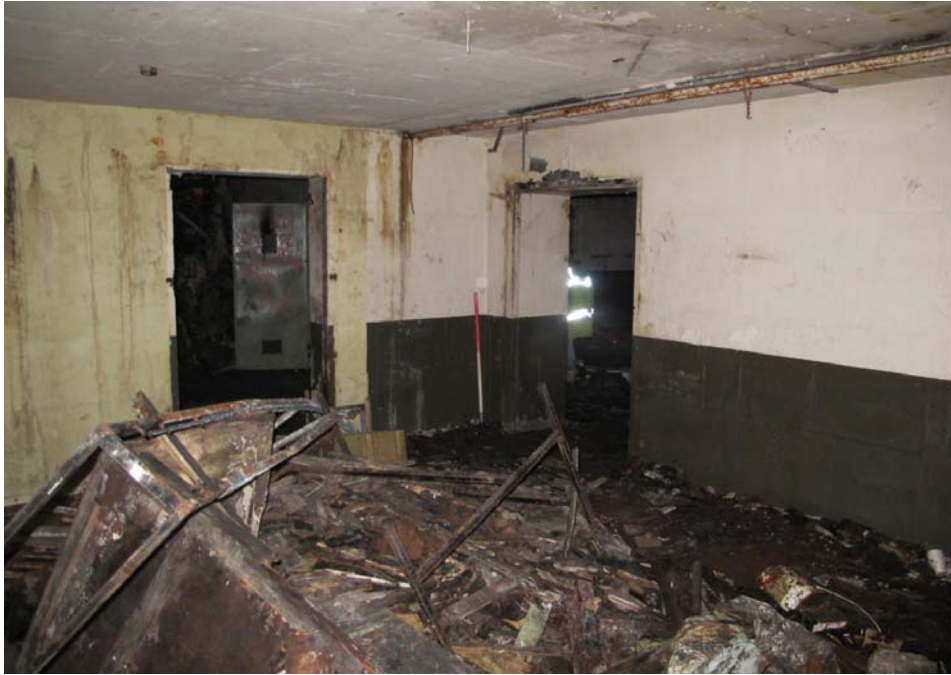
Figure 11: General shot of western room G3, showing the northern and eastern doorways. Looking northeast.

This room lay in the south-western portion of the building. Access to G3 was from corridor G1 to the south and from the central operations room G4 to the east. The room measured 4.27m x 5.50m. The floors, ceilings and walls were constructed from reinforced concrete slabs and covered in square tiling. No other features were present

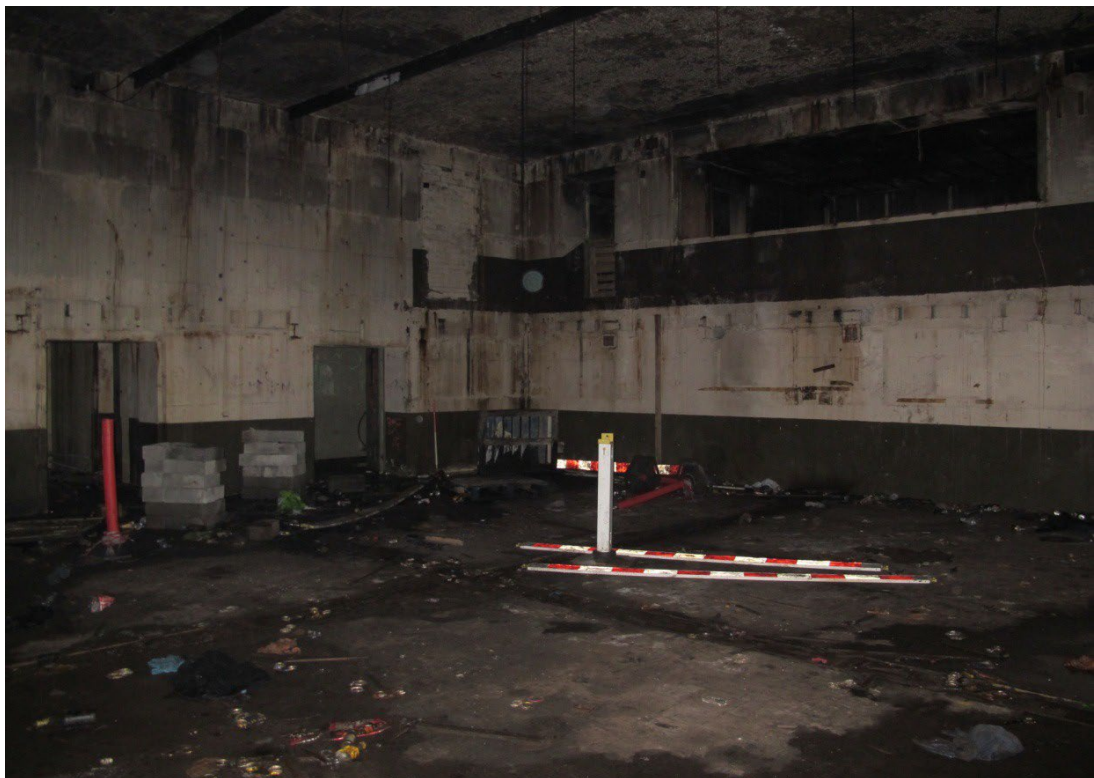
Figure 12: General shot of the main operations room G4 showing its western access points.
The shot also shows the viewing gallery F5 on the first floor. Looking north-west.

This was located in the central portion of the building. G4 was the largest room in the building measuring 10.43m x 10.97m. The room had four points of access; from the west through corridor G1 and room G3 and from the east through corridor G1 and room G10. The viewing gallery (G7) located above the room to the north clearly identified this space as the main operations room. The walls, ceiling and floors were constructed from reinforced concrete slabs. Across the ceiling laid east to west were metal lighting strips and the remains of electrical cord that would have originally carried overhead lights. Strips of metal were also found on the walls (Fig 13). These were probably used as a mounting for shelves or cabinets. At least four blocked doorways were identified running around the top of G4 at first floor height. These doorways would have originally led to rooms F2 and F7 on the first floor. Two open doorways at the same height were also identified located either side of the viewing gallery in F5. These access points infer that a spectator's gallery originally ran over or around the top of the operations room with access to both G4 and the various first floor rooms. This notion is supported by the presence of beam slots running around the circumference of the room at the same level. The room was found to be full of debris from all periods.

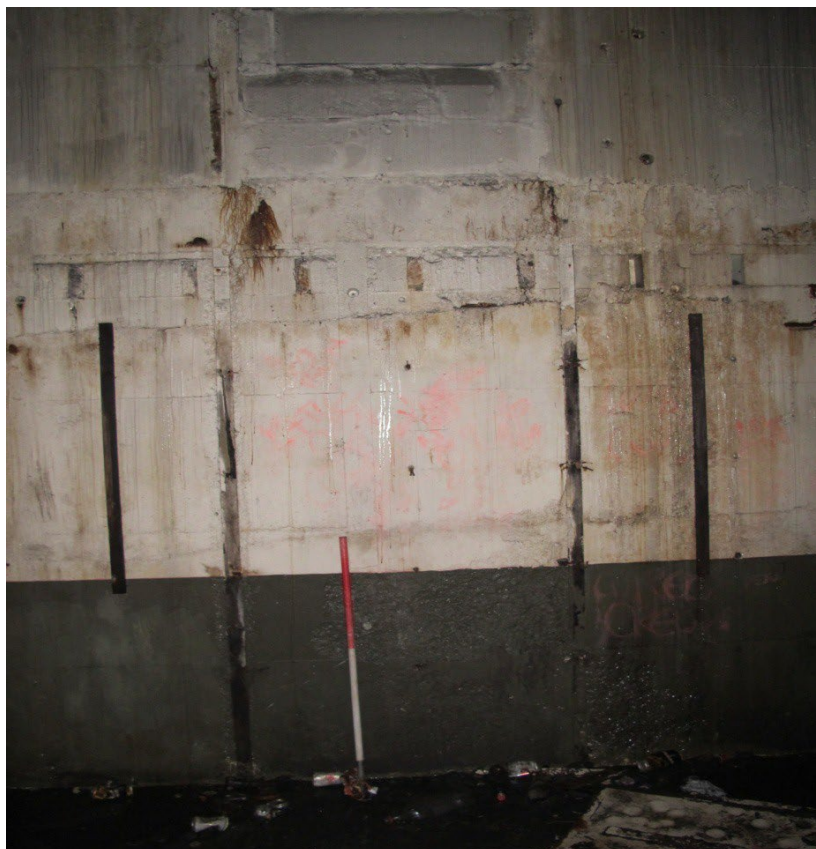
Figure 13: Detail of fixings for possible shelving on the east facing wall of the main operations room G4. Looking west.

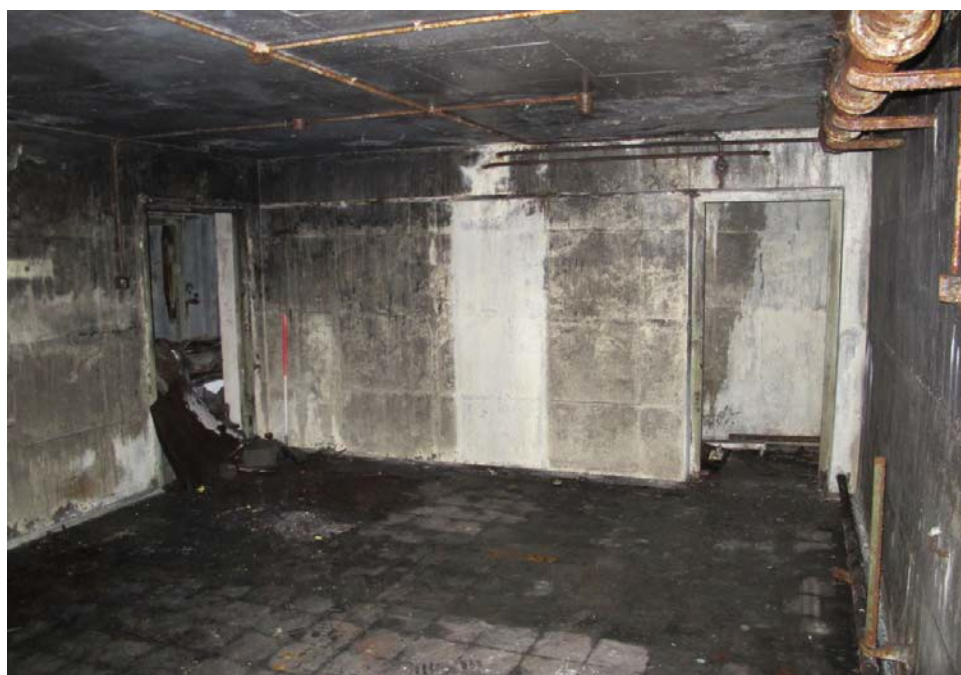
Figure 14: General shot of north-western room G6, showing the southern doorway and access to the western side room. Looking southwest.

This lay in the far north-western corner of the building. The room measured 5.64m x 4.57m. The floors, walls and ceiling were constructed from concrete. Iron pipes and light fittings ran at ceiling level across the extent of the room. No other fixtures or fittings were present. G6 could be accessed from two doorways along the room's northern wall, both of which led into corridor G1. At the western end of G6, a doorway led into a narrow side room measuring 3.20m x 0.92m. The only access into this room was through G6. This side room was void of any fixtures and fittings.

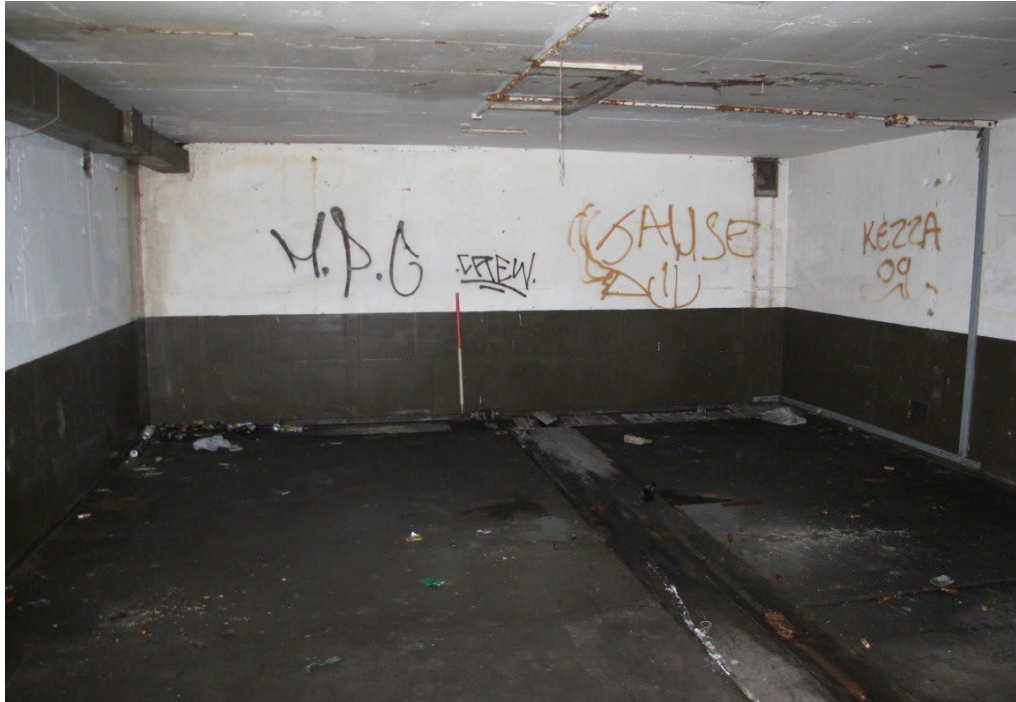
Figure 15: General shot of room G7, showing the floor with a 'T-shaped' wooden in-lay. Looking west.

This room was located in the southern central portion of the building. The room measured 6.40m x 5.71m. The floor, walls and ceilings were constructed from reinforced concrete slabs. Light fittings ran at ceiling level. An air vent system ran along the top of the northern wall. A 'T-shaped' wooden inlay ran north-south across the main floor of the room. A groove running down the centre of this wooden inlay suggested that this feature was a runner for mobile shelving or screens.

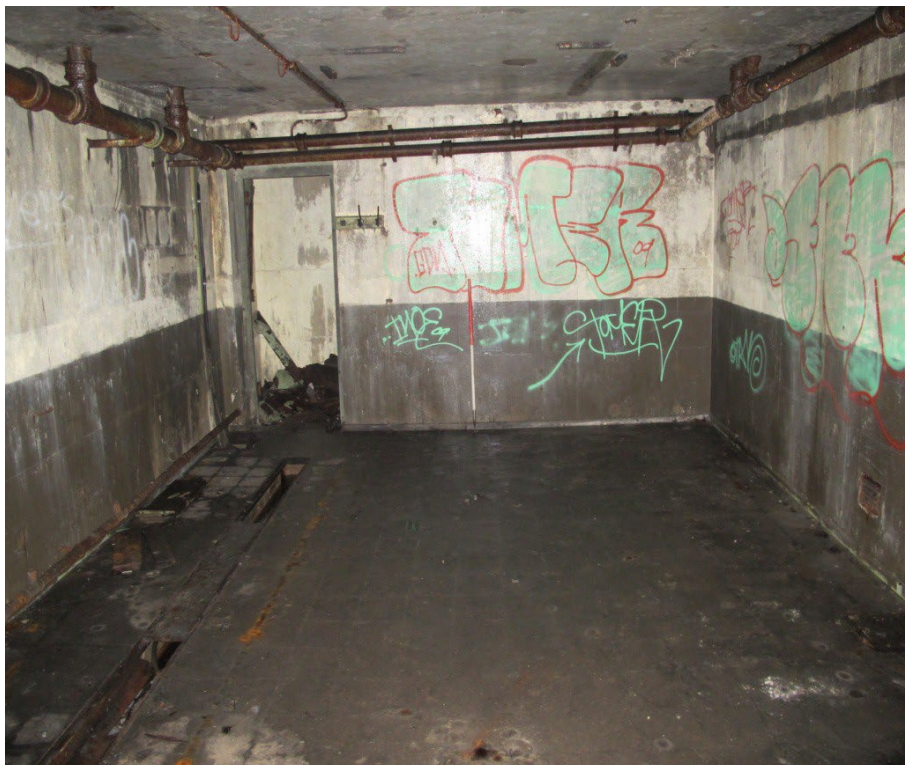
Figure 16: General shot of room G8, showing doorway leading to staircase S4. Looking east.

This lay in the far north-eastern corner of the building, and was a mirror image of room G6. The room measured 5.64m x 4.57m. The room could be accessed from the west through a 1.52m wide doorway from corridor G1. At the eastern end of G8, a doorway led into a narrow side room. This room measured 3.20m x 0.92m. A likely use of this

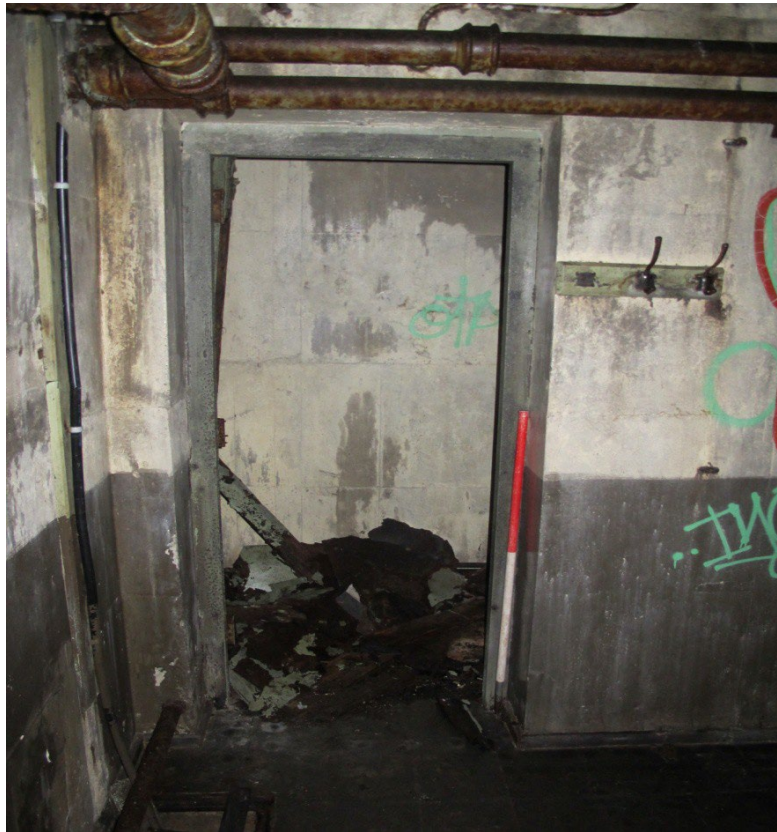
Figure 17: Detail of doorway in room G8 leading to staircase S4 showing wall mounted coat hooks. Looking east.

space would be for storage purposes. Iron heating pipes and light fittings ran around the top of the room at ceiling level. At the eastern end of the room, the remains of three wall mounted iron coat hooks (Fig 17) were found to the south of the doorway leading to the side room.

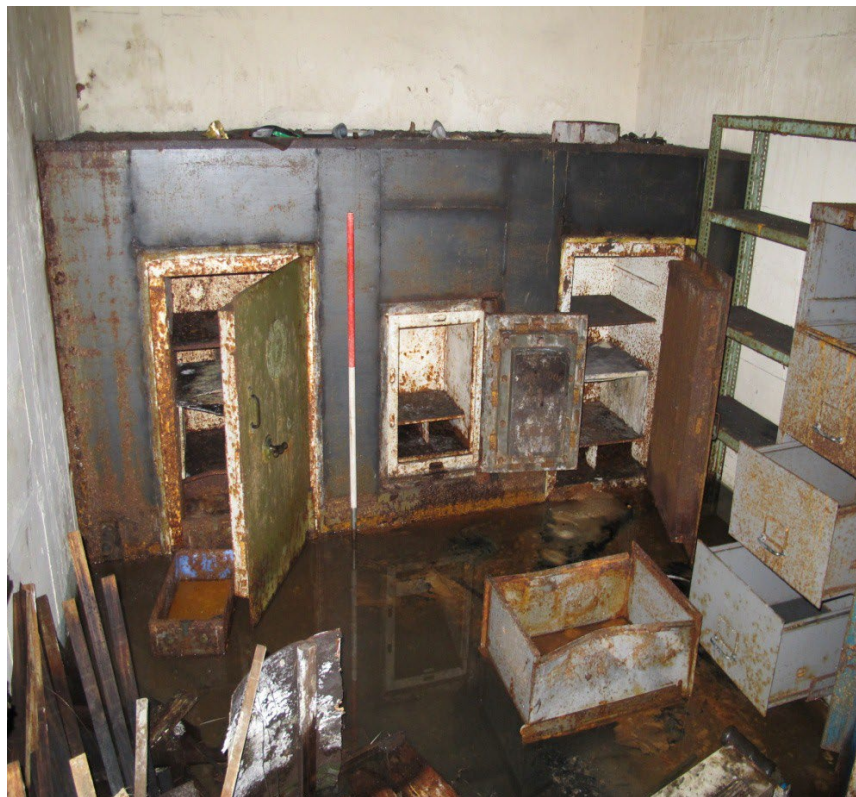
Figure 18: General shot of the safe room G9, showing the three cast iron and steel safes along the south wall. Looking south

This room lay in the eastern half of the building, directly opposite room G8 in the west half of the building. The room measured 5.50m x 3.05m. The only access into this room was from the north through a reinforced steel framed cast iron safe door. The door was painted gray and embellished with the maker's stamp on the inside of the door: 'Chatwood Milner Ltd, London, England' (Fig 19). Along the south wall of the room were three fitted cast iron/steel safes all of which were found to be empty and open. The eastern safe was embellished with the logo: 'Samuel Withers & Co, West Bromwich'. To the west of the safes, along the room's western wall was one set of steel shelving units. Adjacent to these units was a four tiered grey filing cabinet which were found open and empty. Next to the filing cabinet were two blue steel cabinets. Other shelving units were found lying on the ground amongst general debris.

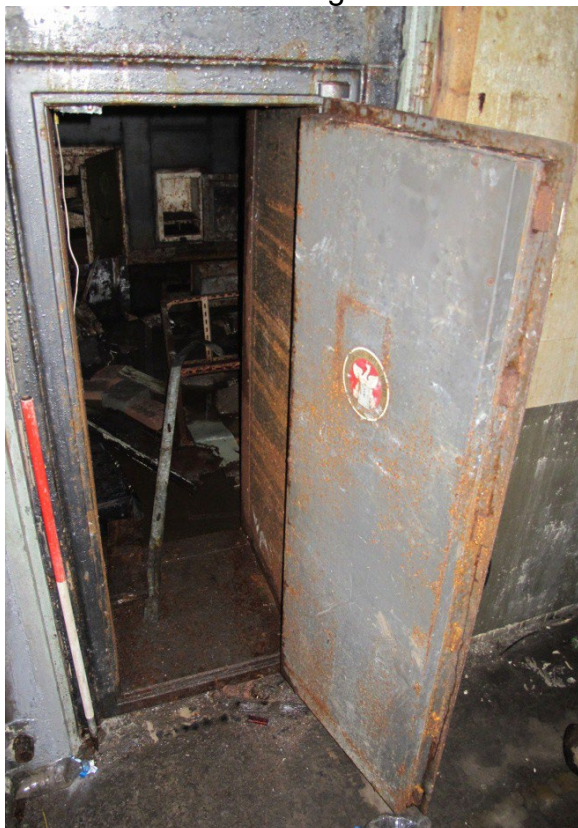
Figure 19: Detail of the main door into to the safe room G9. Note the reinforced steel surround and double thickness iron door. Looking south.

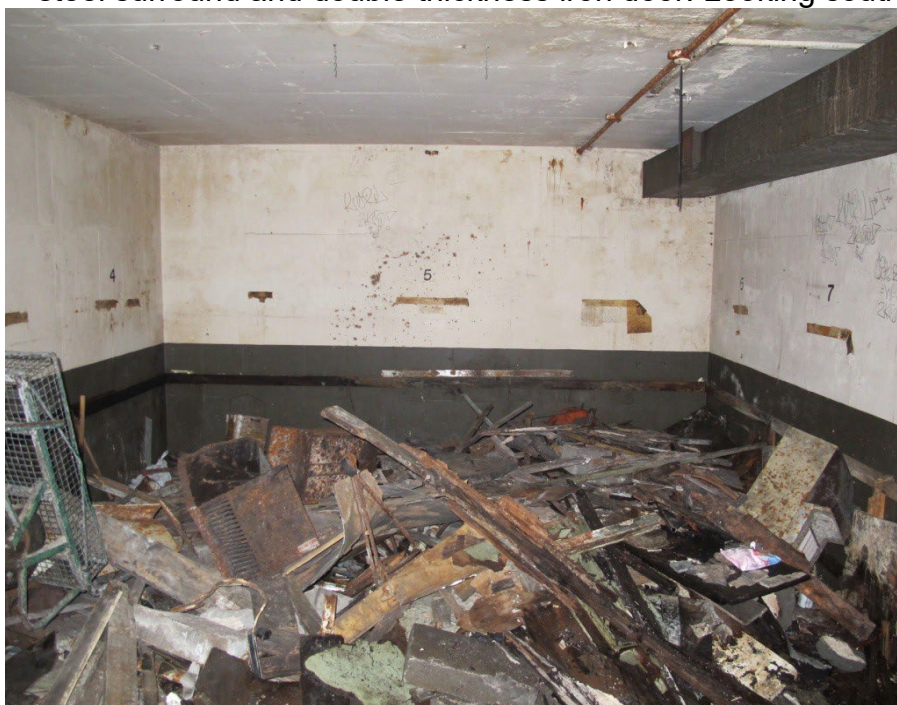
Figure 20: General shot of eastern room G10 partially filled with debris. Looking south.

This lay in the southeast portion of the building and was a mirror image of room G3. G10 measured 4.27m x 5.50m. The room could be accessed from the north via corridor G1 or from the west by the central operations room G4. A single strip of metal ran around the room at mid level. Light fittings and a ventilation shaft ran north-south across the room at ceiling level. The room was found to be full of debris.

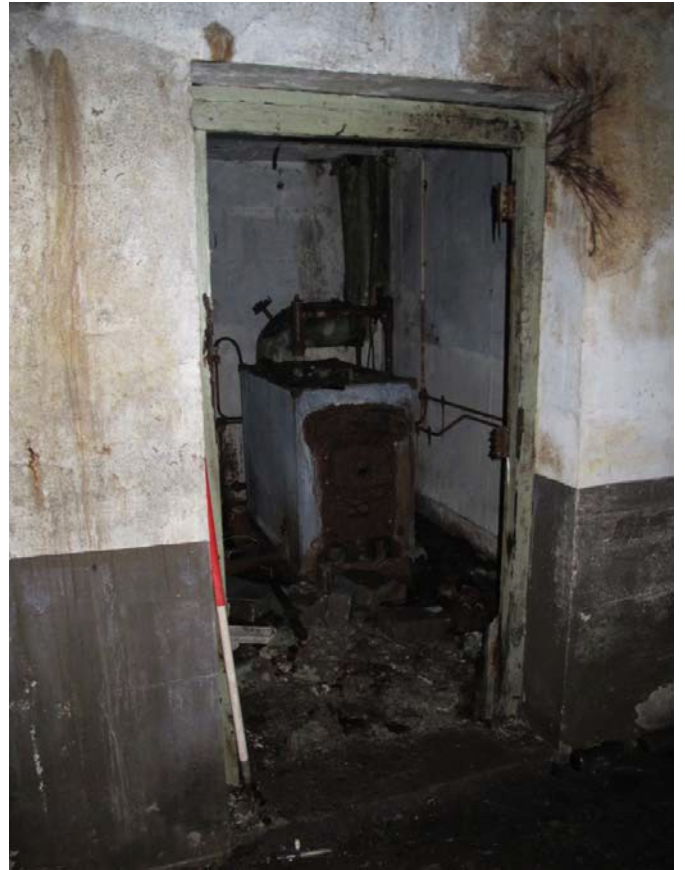
Figure 21: Shot of the northern doorway into the boiler room G11 from corridor G1. The boiler itself can be seen in the south- western corner of the room. Looking south.

This room was located in the far southeast corner of the building. The room measured 3.05x 2.60m and was accessible from the north by corridor G1. In the southwest corner of the room was a cast iron/steel boiler (Fig 22). Running from the back of the boiler up and through the ceiling was a flue. Various iron pipes ran off the east side of the boiler. Fitted to the east wall of G11 were the remains of two iron supporting bars, probably used to hold machinery associated with boiler (Fig 23). Various light fitting and control switches were found mounted to the west wall of G11 under an air vent.

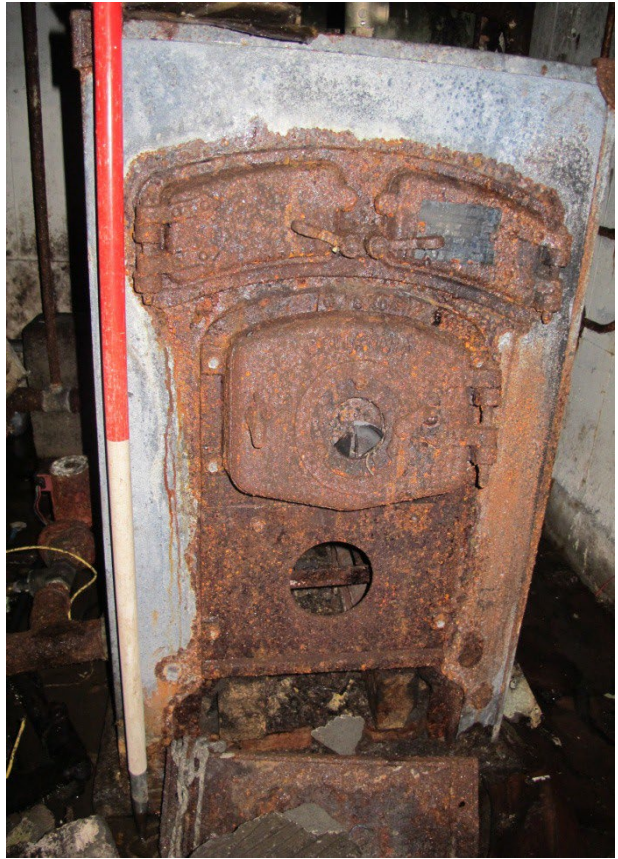
Figure 22: Detail of the cast iron boiler in room G11.

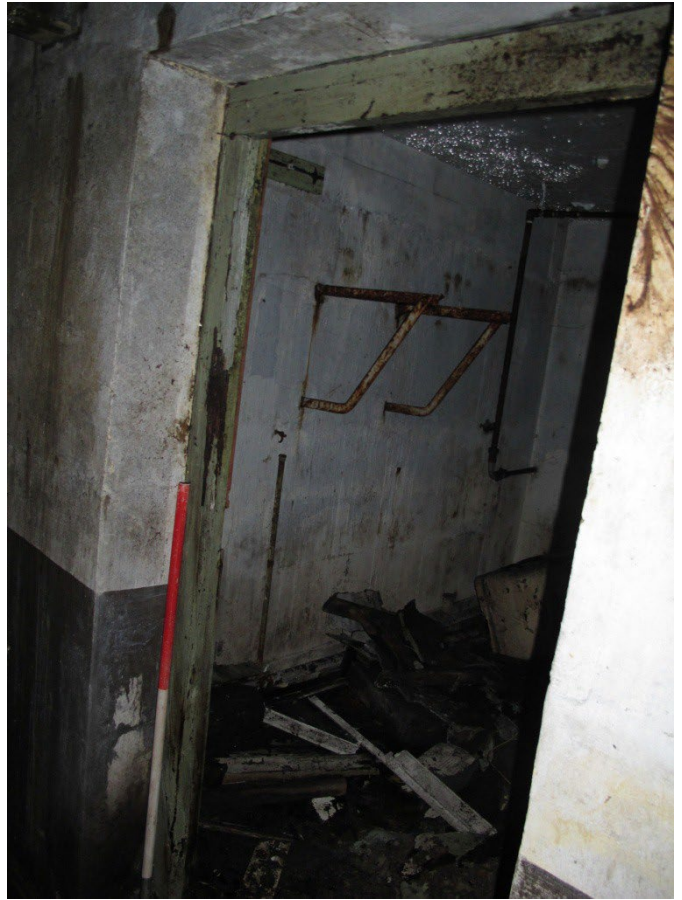
Figure 23: Detail of wall mounted support bars on the west facing wall of room G11.

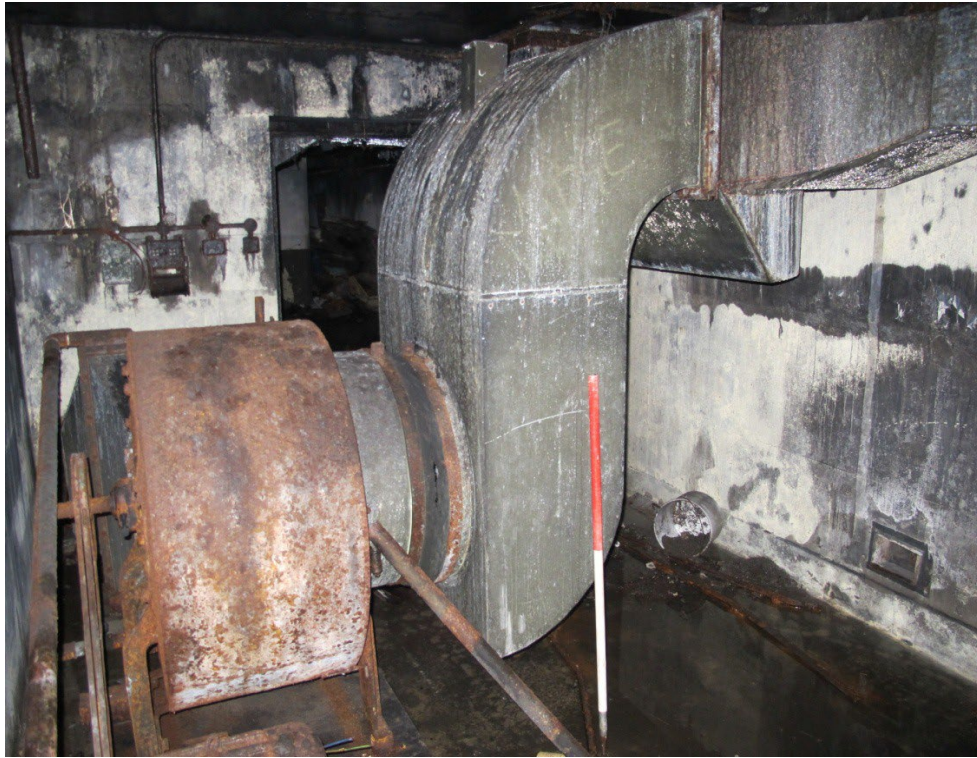
Figure 24: Shot of the air ventilation room G12, showing the central air handling unit for the building. Looking west.

This lay directly to the west of room G11. The room measured 4.71m x 3.06m and was accessible from the west by corridor G1. The room contained a large iron/steel air handling unit, the central component for the building's ventilation system. The controls for the system and the room's lighting were located on the western wall. An additional wall mounted control was located on the eastern wall (Fig 25).

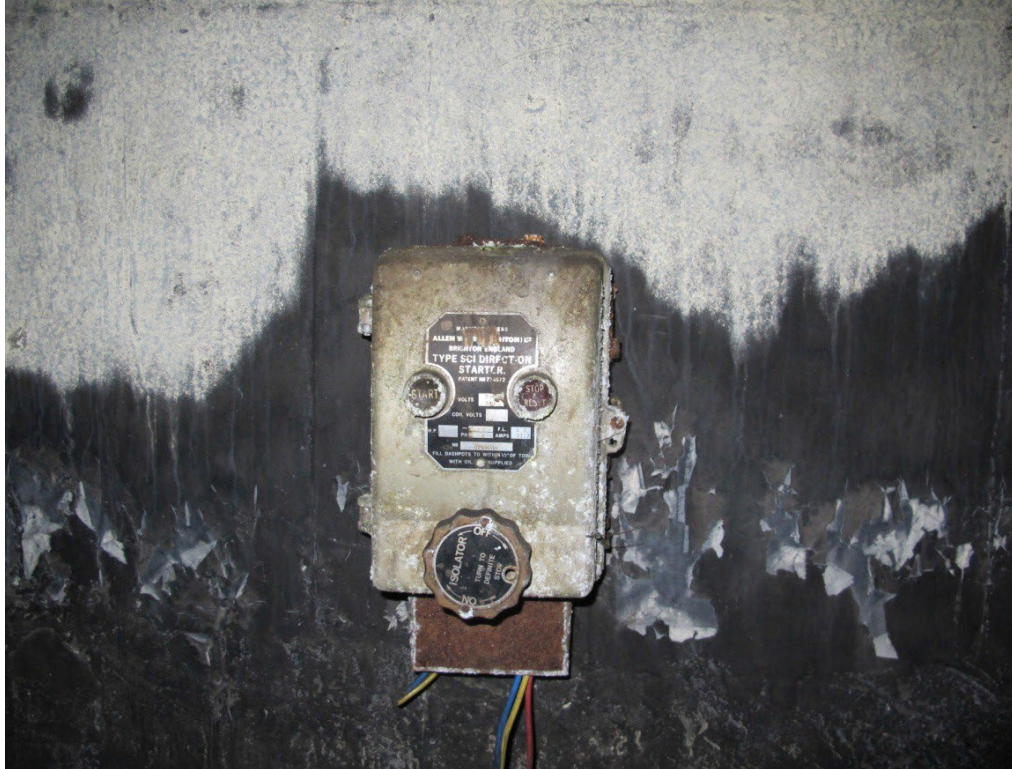
Figure 25: Detail of wall mounted control device for the ventilation unit in room G12. The device was fixed to the south facing wall of the room.

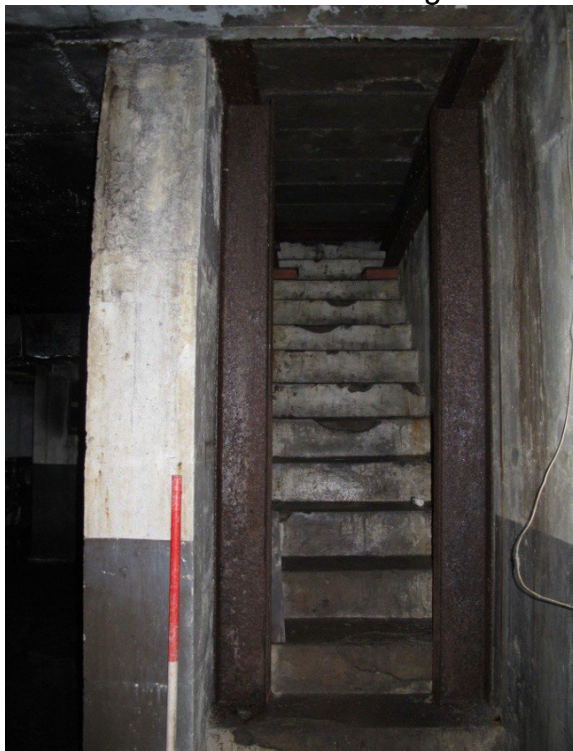
Figure 26: Detail of stairwell S1 which rose from corridor G1 to room F1 on the first floor. Access to F1 was found to be blocked by a wooden hatch built into the floor of F1.

Stairwell S1 (Fig 26) was located at the very south of the building. The stairs rose from an entrance flanked by two steel posts in corridor G1 to room F1 on the first floor. The staircase was found to be blocked at the top of its flight by a wooden hatch laid into the floor of F1 (Fig 31)

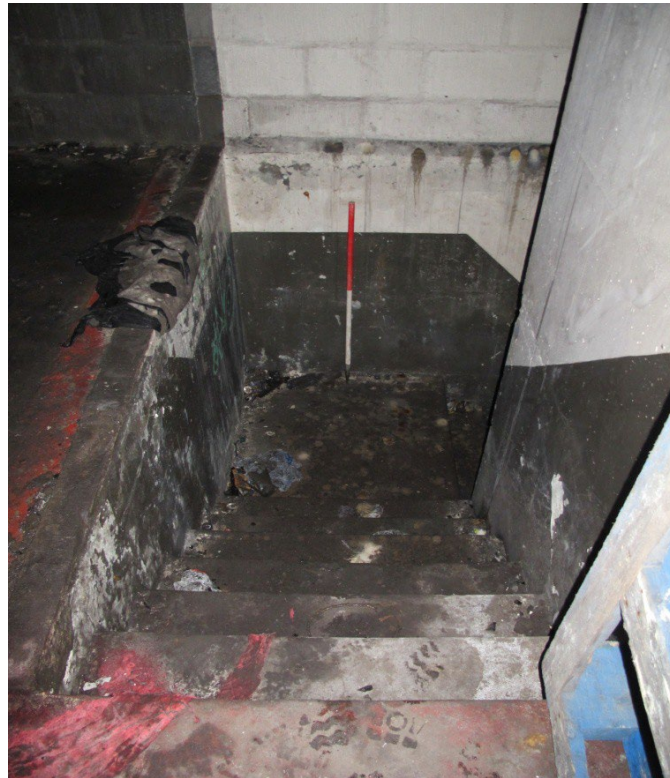
Figure 27: Shot taken of eastern stairwell S3 taken from corridor F4 on the first floor. Looking east.

Stairwell S3 (Fig 27) was located in the eastern half of the building. The stairs rose from corridor G1 to corridor F4 on the first floor. The stairs provided direct access to the viewing platform G7 on the first floor.

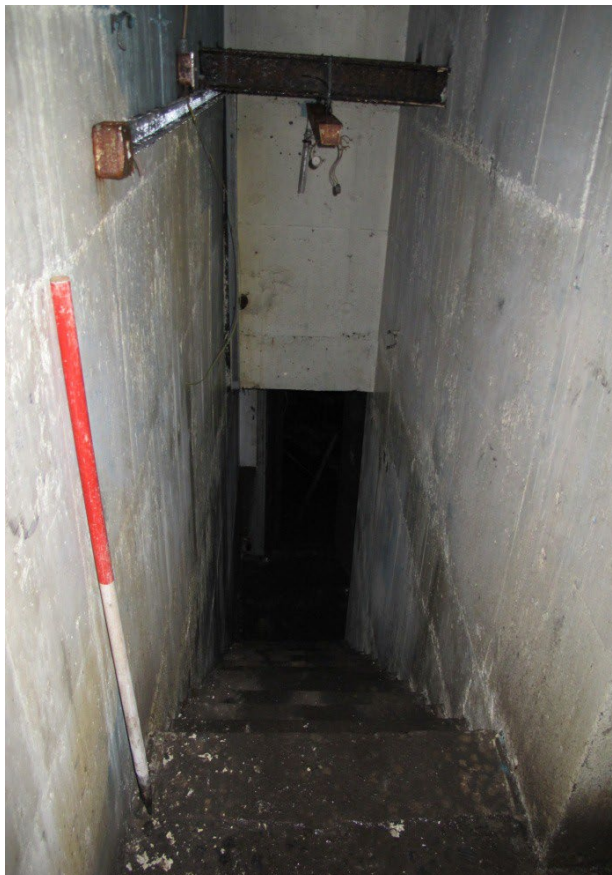
Figure 28: Shot taken of north eastern staircase S4, looking down the staircase from toilet room F6. Looking south.

Stairwell S4 (Fig 28) lay in the far northeast corner of the building. The stairs rose from corridor G1 on the ground floor to the toilet block in room F6 on the first floor.

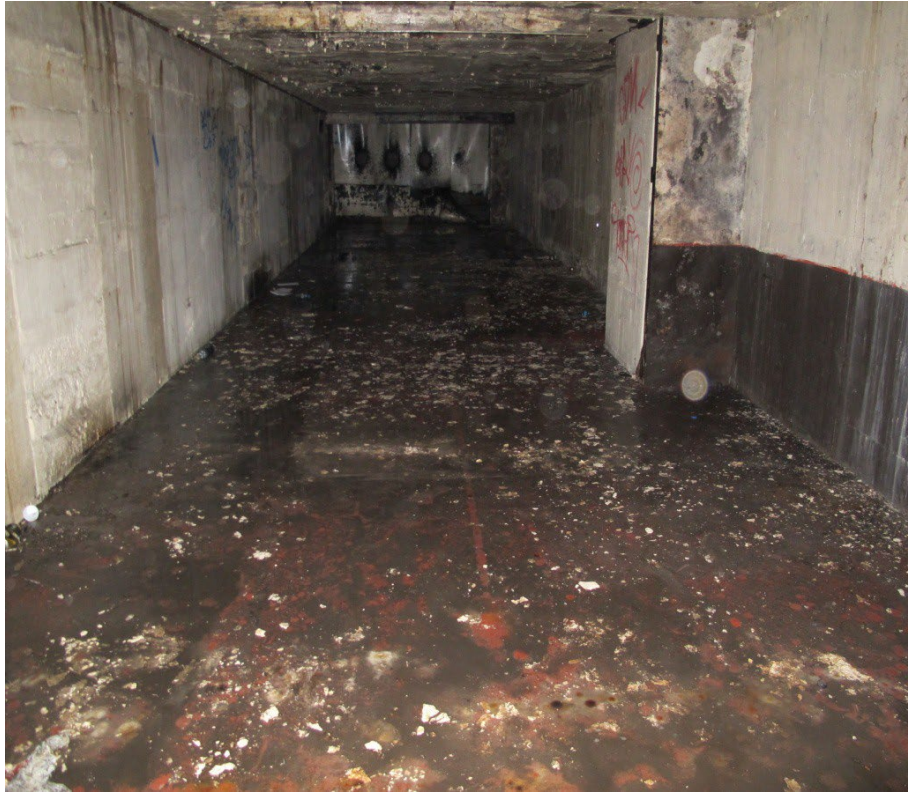
Figure 29: General shot of the long range shooting gallery in F1.

This room was located in southern part of the building. The room ran the full width of the building, along its southern external wall. F1 measured 21.70m x 4.60m. The floors, walls and ceilings were all constructed from reinforced concrete slabs. Access to F1 was from the west through a door in the northern partition wall. At the far western end of the room was a row of four shooting targets made from sheet metal. It is likely that these sheets originally lay behind superimposed circle targets. Behind the metal sheets was the 'butts' or backstop where the pellets used for shooting would have been contained and collected. A power control box was located on the room's western wall (Fig 30). Laid in to the floor, along the southern wall of F1 was a square wooden hatch (Fig 31). The hatch was found to block the top of stairwell S1.

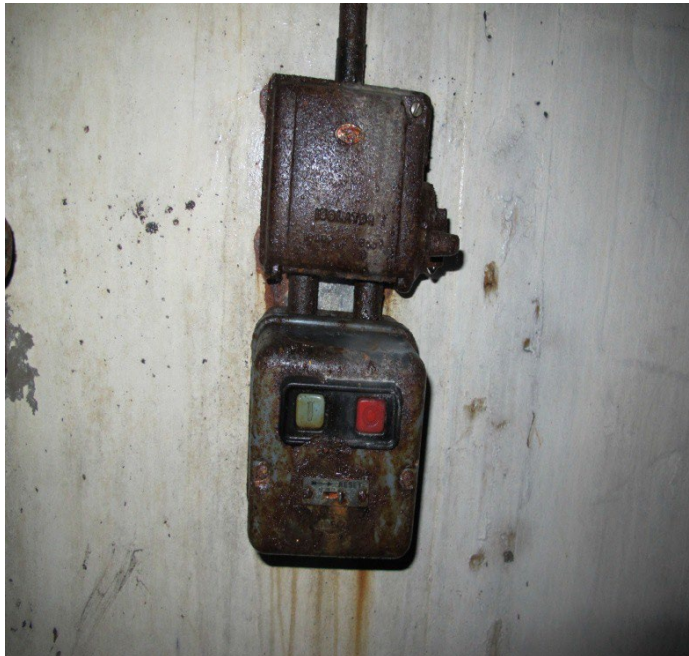
Figure 30: Detail of a power control system mounted on to the south facing wall of room F1. Looking north.

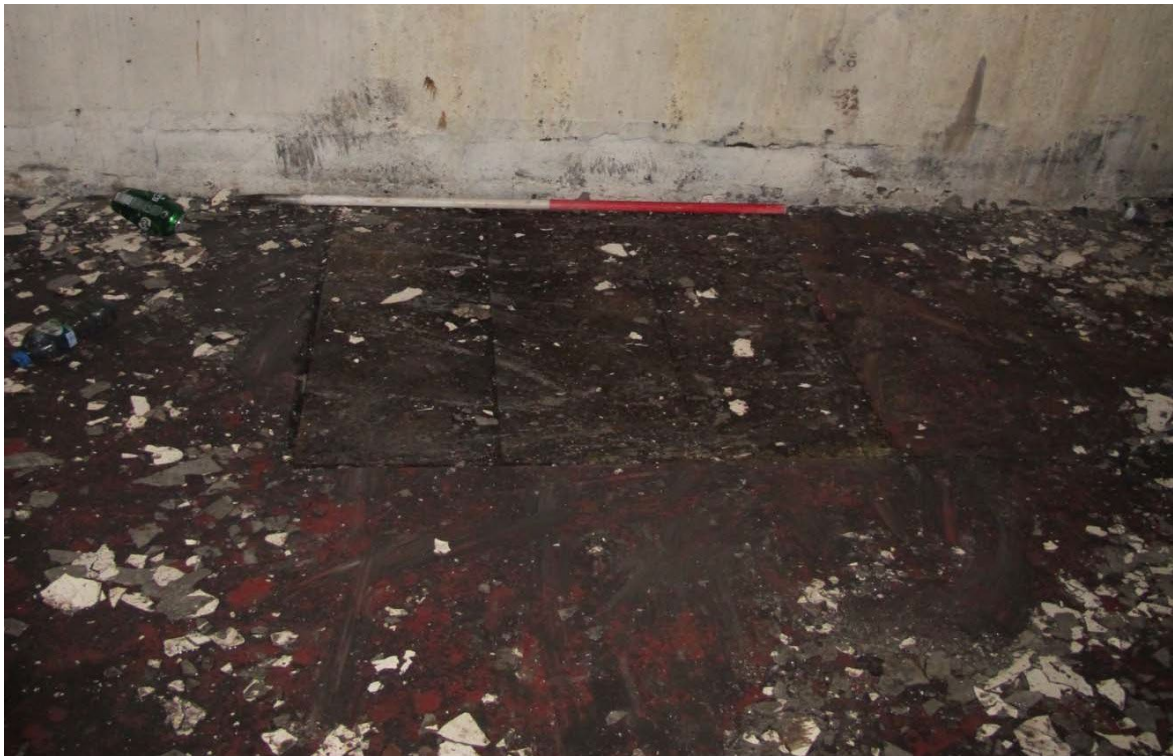
Figure 31: Detail of blocked southern stairwell S1 in room F1. The wooden hatch marks the location where the stairs would have risen to from corridor G1 on the ground floor.

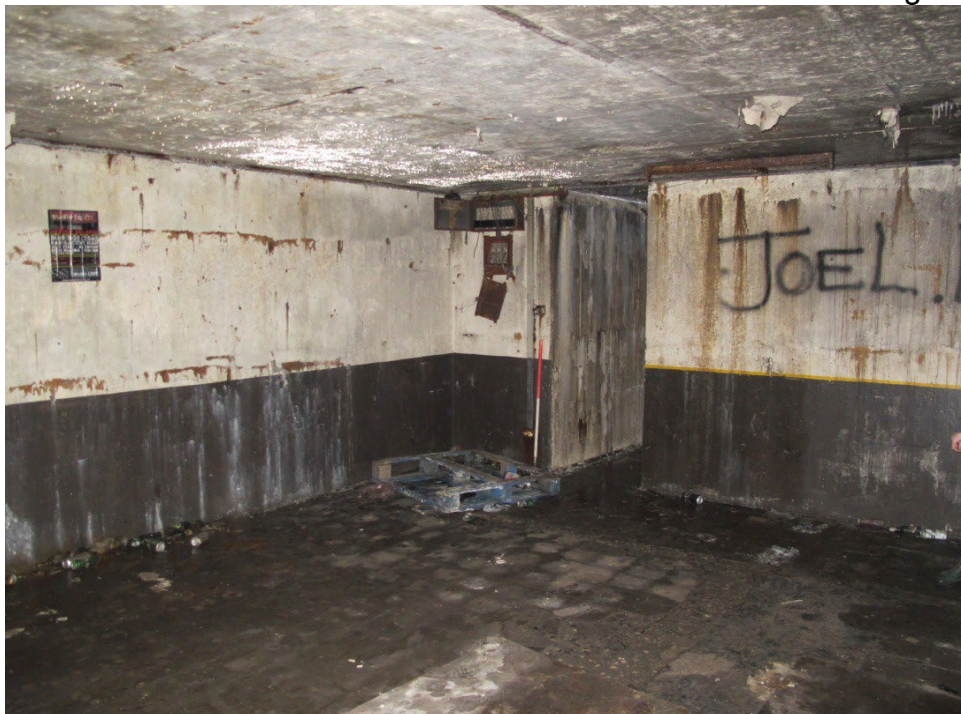
Figure 32: General shot of room F2 showing the access to room F3 along the northern wall and a series of possible fuse boxes in the northwest corner of the room. Looking northwest.

This was located in the western portion of the building, aligned north-south along the western exterior wall. The room measured 14.35m x 5.80m. The floor and walls were constructed from concrete. F2 could be accessed from the south through room F1, from the north by room F3 and from the east by corridor F4. Two blocked doorways were identified along the room's eastern wall (Fig 33). On the north wall were two wall mounted fuse boxes.

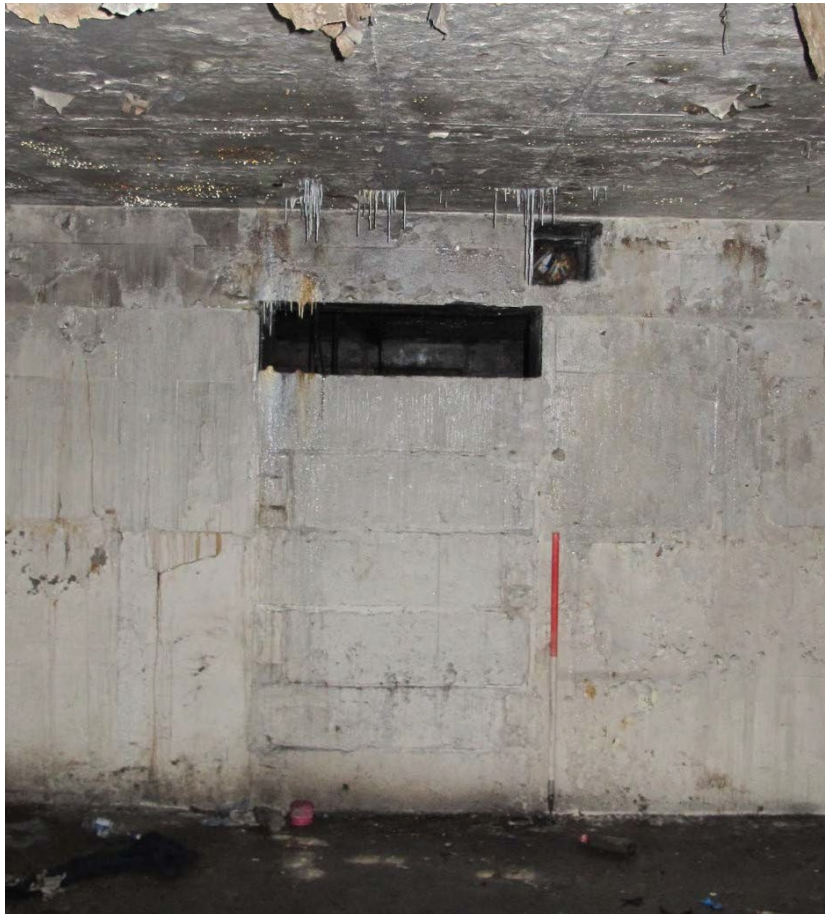
Figure 33: Detail of the most southerly blocked doorway along the east wall of room F2. This doorway would have originally lead to a walkway or room that ran around the top of the main operations room G4. Looking east.

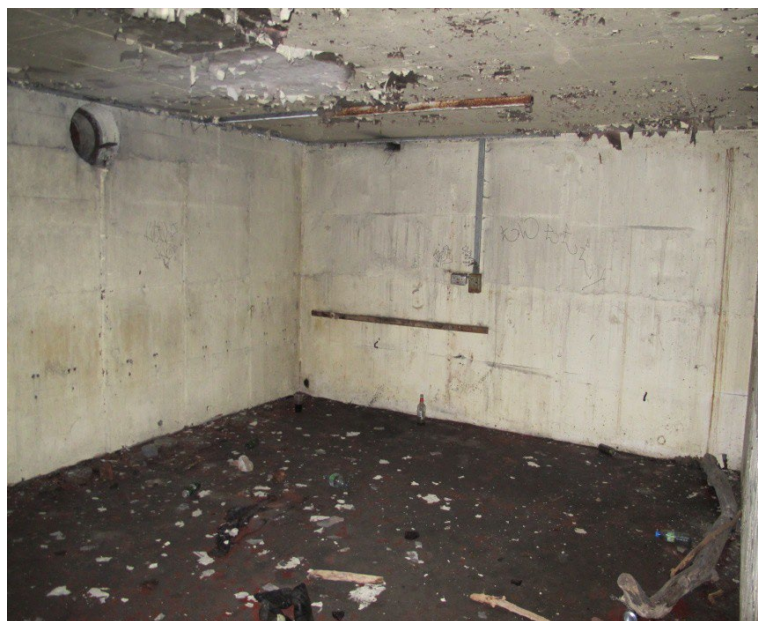
Figure 34: General shot of room F3 showing light switch on the north wall and an open air vent cut through the west wall. Looking north.

This room lay directly to the north of room F2 and could only be accessed from this room. F3 measured 4.26m x 5.77m. All walls were built with breeze blocks and coated with a white- wash paint. An open circular air vent leading outside the building had been cut in to the north wall. Two sets of wall mounted light switches were identified on the east wall. A 1m wide doorway located in the northwest corner of the room lead into a rectangular side room measuring 3.00m x 1.00m. At the time of this survey this room was full with debris.

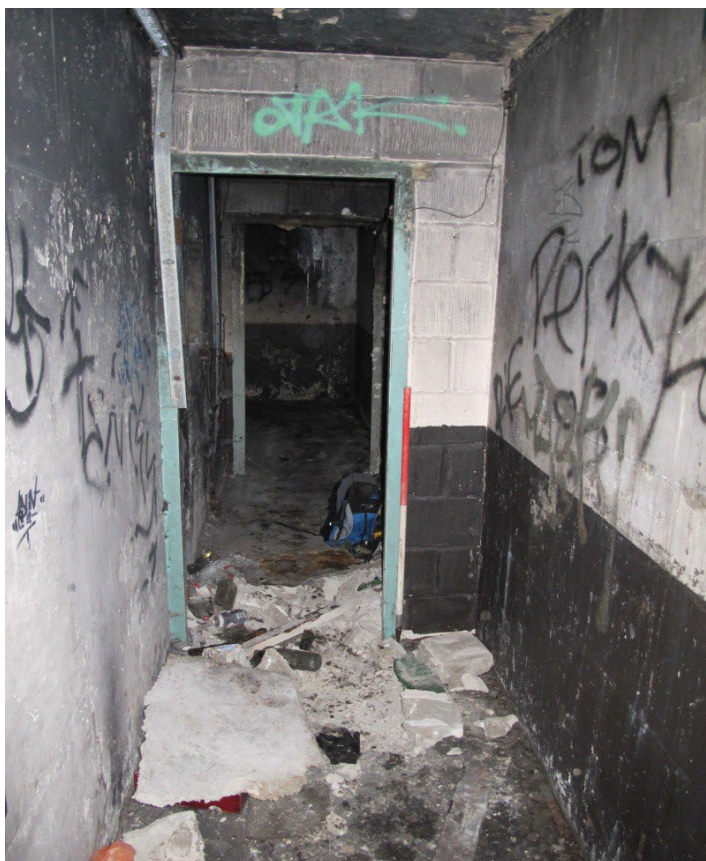
Figure 35: General shot of corridor F4 looking west down the east-west aligned section of the corridor.

This lay in the northern part of the building and was found to run around the viewing platform area F5. The corridor provided access to eastern room F2, the viewing platform F5, and the toilet block F6. Staircase S3 rose to meet F4 from the ground floor. The corridor appears to terminate either side of the viewing gallery at two open doorways that drop straight down to the operations room on the ground floor (Fig 36). The corridor was found to be constructed from concrete blocks which had been painted black from their mid section down to the floor. The north-east aligned section of F4 was found to have a small square window cut through its southern wall into the north wall of the viewing platform room (Fig 37). A single strip of metal had been laid round the ceiling of the corridor. It is presumed this was for mounted ceiling lights.

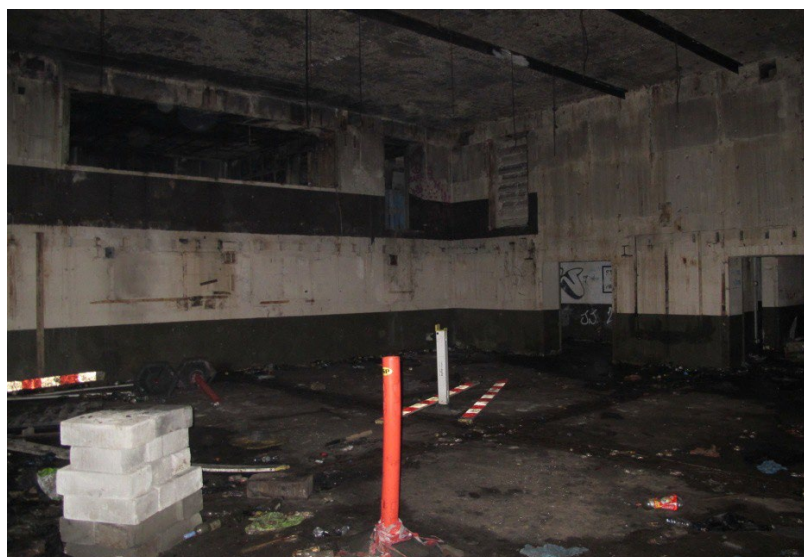
Figure 36: General shot of the main operations room showing the eastern end of corridor F4 terminating with an open doorway on the first floor. Looking northeast.

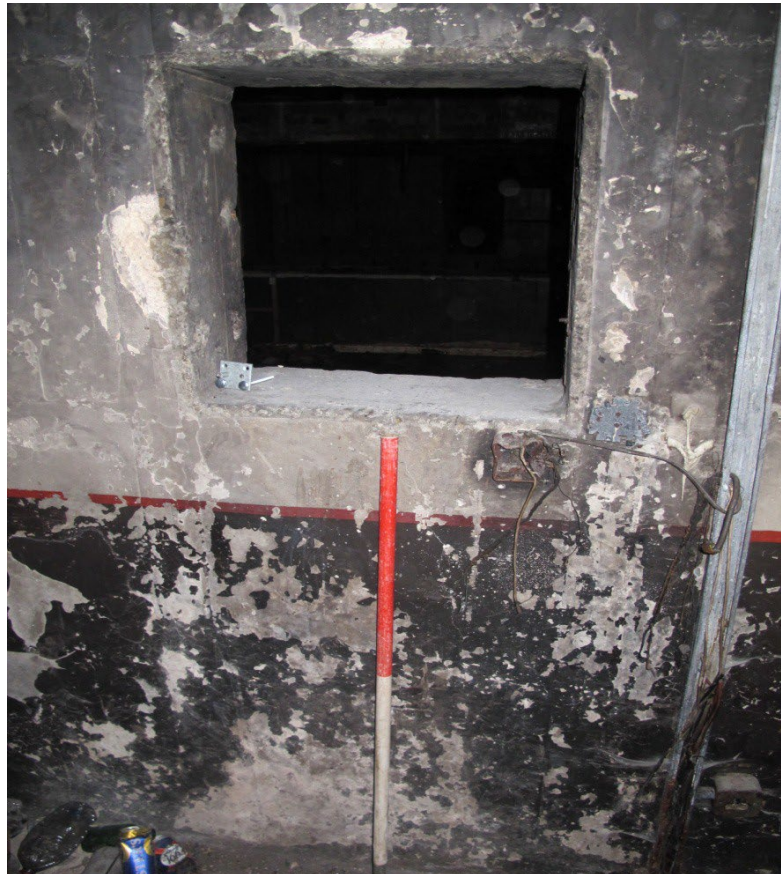
Figure 37: Detail of a window cut into the partition wall between corridor F4 and the viewing gallery room F5. Looking south.
