**Archaeological
Building Survey:**

Worsley New Hall
Cold War Bunker,
Worsley. Final
Version.

Client: Peel
Investments (North)
Ltd.

Report No: 02/2012

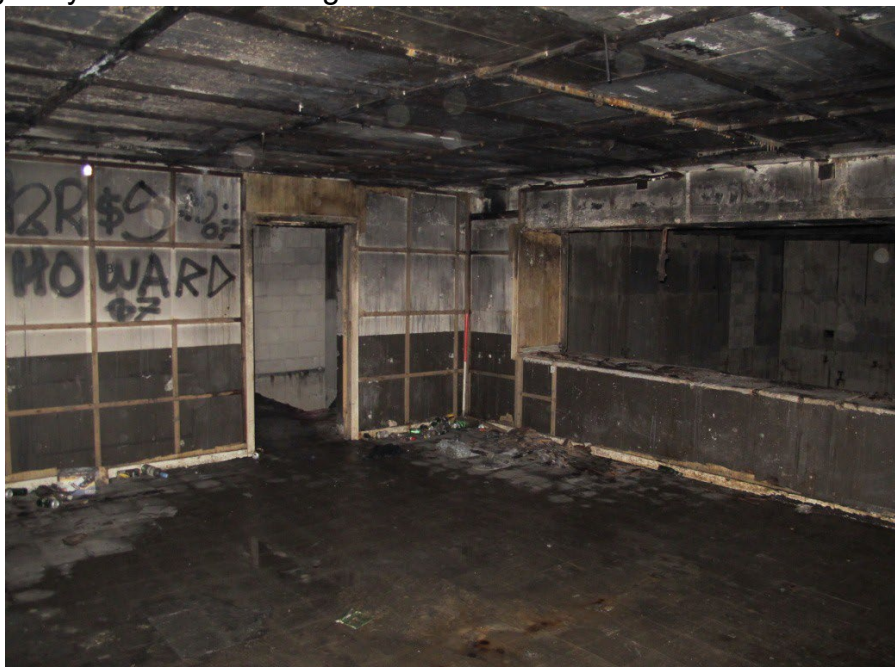
Figure 38: General shot of the viewing gallery room F5 showing the eastern doorway and the viewing window that looks down on to the main operation room G4. The walls and ceiling were found to be covered in wooden framing, a likely mounting for wooden panels. Looking southeast.

This room lay in the northern part of the building and was partially surrounded by corridor F4. The room measured 6.42m x 5.48m. The southern wall of the room was made from solid concrete and was partially open. This opening provided the building with a large viewing gallery for the central operations room (G4) that lay below on the ground floor. The northern, eastern and western walls were constructed from breeze blocks. Covering the extent of these three walls and the ceiling were the remains of wooden frames, very likely to have been a mounting for wooden panels. Access to this room from G4 was through two doorways in the northeast and northwest of F5. Staircase's S2 and S3 provided access to the viewing gallery from the ground floor.

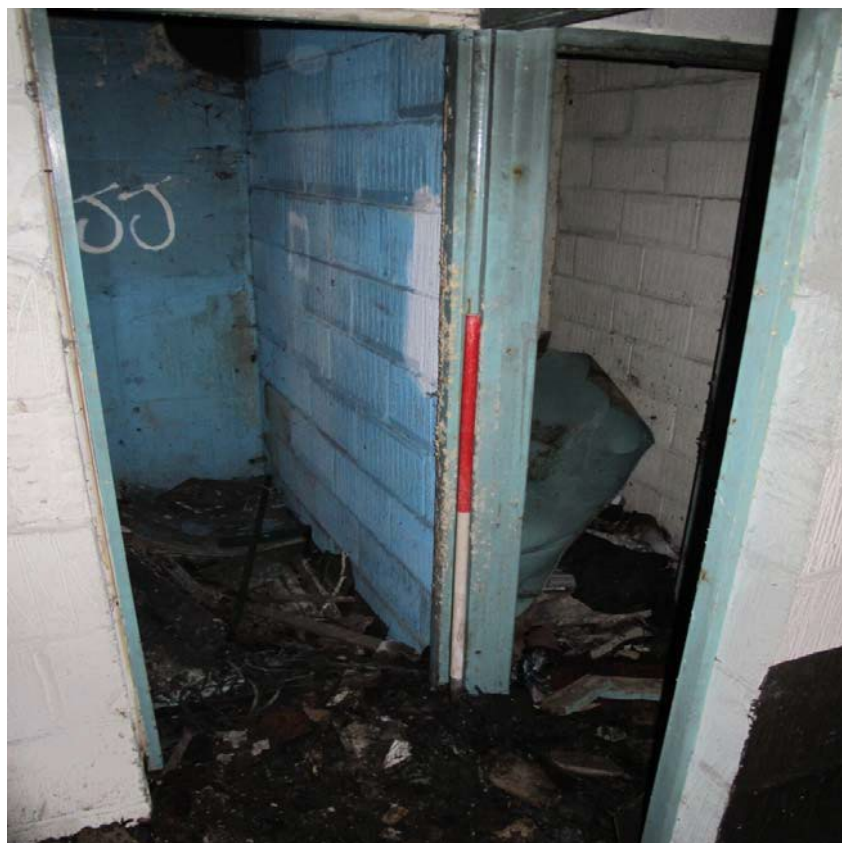
Figure 39: General shot of the breeze block toilet block in north-eastern room F6. Looking northeast.

This was located in the far north-eastern corner of the building. The room comprised of three breeze blocked south facing toilet cubicles. There were three points of access to this room: two to the north by corridor F4 and room F7 and one to the west by staircase S4 which rose to F6 from the ground floor. A metal fan probably associated with the air venting systems was found running through the mid section partition wall in room F6 (Fig 40). It was clear that the toilets were a later addition and the room would have originally been an open space, mirroring the image of room F3 in the north-west corner of the building.

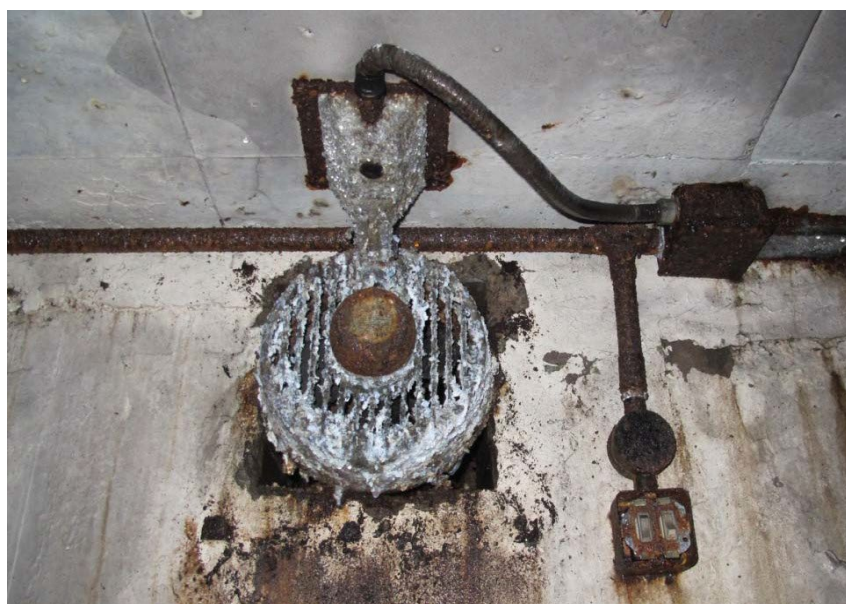
Figure 40: Detail of a corroded fan located on the east-west aligned partition wall in room F6. Looking north.

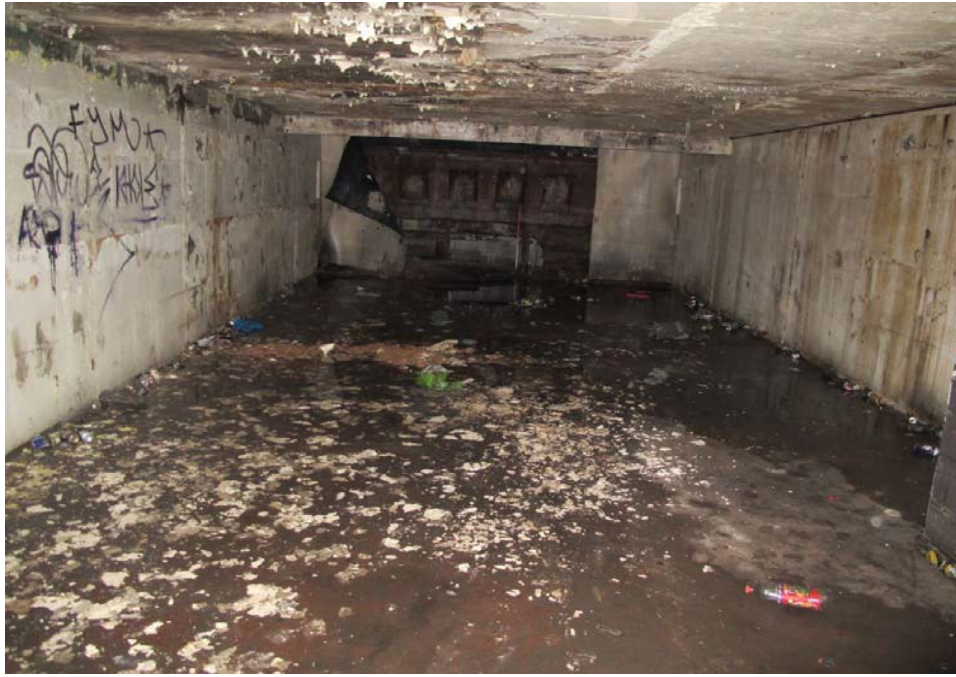
Figure 41: General shot of the short range shooting gallery in room F7, showing the metal sheeting of the butts area at the southern end of the room.

This room was located in the eastern portion of the building. The room was north-south aligned and measured 13.37m x 5.79m. Access to the room was from the north by a doorway in the north wall. The walls, ceiling and floor had been constructed from reinforced concrete slabs. The presence of five angled plates at the southern end of room suggested that the purpose of the room at the time of the survey was a short range shooting gallery. These angled plates would have been located in the butts, the area behind the targets (Fig 42). The targets themselves had not survived. Two blocked doorways were identified along the western wall (Fig 43) that may originally have led down into a room or walkway that ran around the operations room G4 at first floor level.

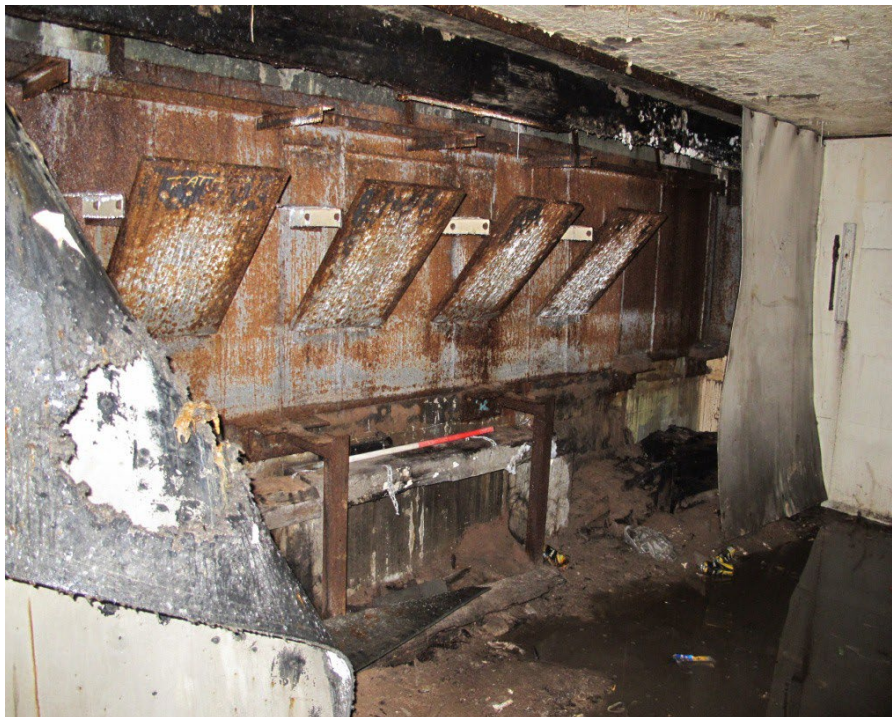
Figure 42: Detail of the butts area behind the damaged target area at the southern end of room F7. Looking southwest.

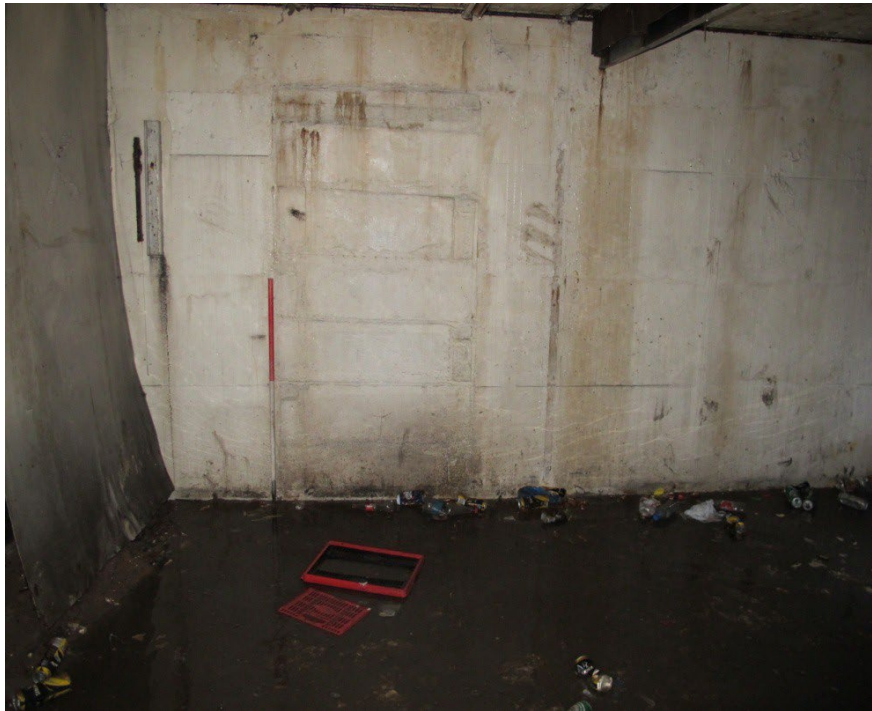
Figure 43: Detail of one of two blocked doorways located along the west wall of room F7. The doorway would have originally provided access to a walkway or room that ran around the top of the main operations room G4. Looking west.
